# Application for Non-Capacity Related Amendment of License

*Annex Creek/Salmon Creek Hydroelectric Project  
(FERC Project No. 2307)*

**Alaska Electric Light and Power Company  
Juneau, Alaska**

**July 2020**

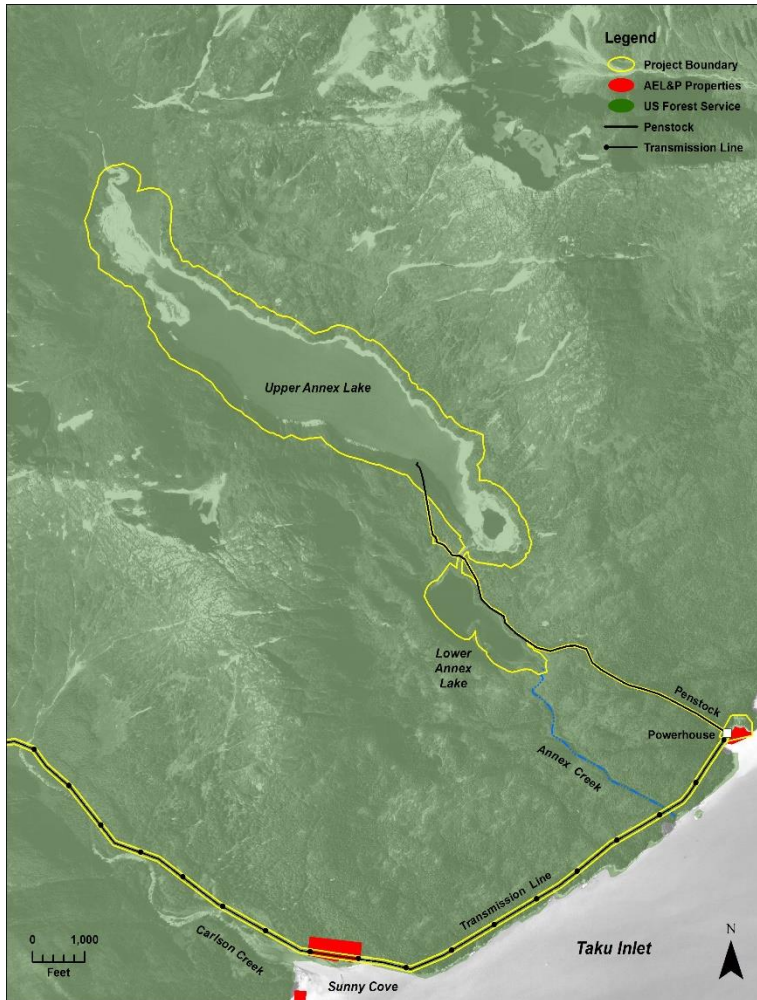
# Site Overview

- The yellow lines are the FERC Project Boundary (Exhibit G)
- Red areas are private properties (AELP)
- All surrounding lands are Tongass National Forest

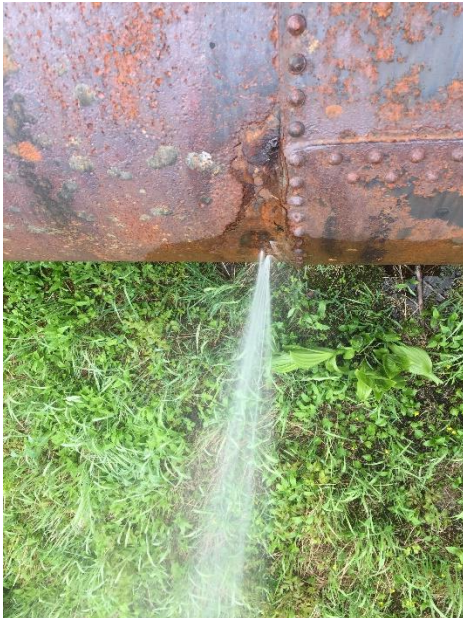
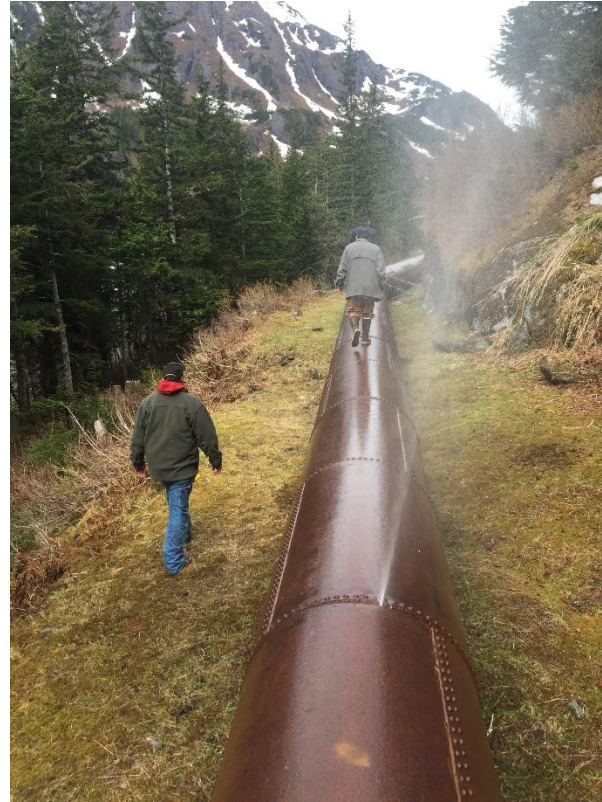
# Why are we doing this?

Late spring 2017 plant was offline for 6 weeks for work on the tailrace, during that time several leaks were noted in the penstock.

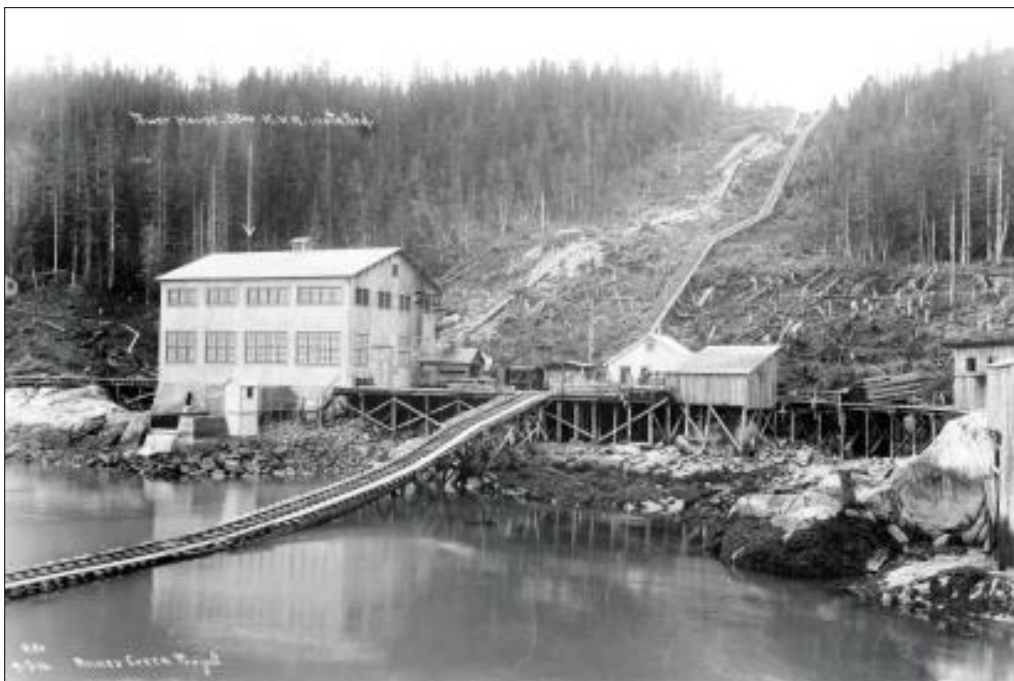
Figure 1-2. Annex Creek Powerhouse, 1916

Between 1912 and 1915, the Gastineau Mining Company constructed first the Salmon Creek and then the Annex Creek (Figure 1-2) facilities. By 1936, all the mining companies and their electrical generating facilities in the Juneau area had been amalgamated into the Alaska Juneau Gold Mining Company (AJ Industries). As AEL&P's load continued to grow, it met its additional energy requirements with power purchased from AJ Industries. When the mines were permanently closed in 1944, AEL&P became the sole purchaser of AJ Industries' hydroelectric energy. In 1963, the Federal Power Commission (FPC) issued a license to AJ Industries for continued operation of the Project on the condition that both the Annex Creek and Salmon Creek dams be rehabilitated. In 1973, AEL&P purchased AJ Industries' hydroelectric generating facilities and transmission system (the existing Project facilities), and the operating license was transferred to AEL&P. AEL&P applied for a new license for the Project in 1985, and FERC issued a 30-year license in 1988. AEL&P applied for a new license for the Project in 2016, and FERC issued a 40-year license in 2018. AEL&P is continuing to operate the project as licensed by FERC. Table 1-2 summarizes important milestones in the history of the Annex Creek Development.

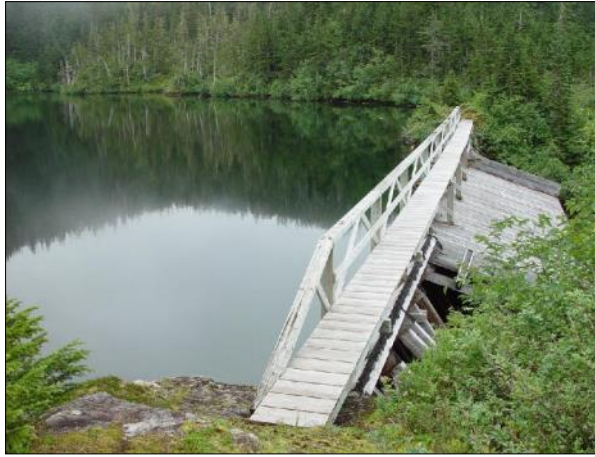
Dam and spillway

A small timber saddle dam 61 feet long is located just west of the main dam. The saddle dam is constructed of 3-inch tongue-and-groove decking supported by 4-inch by 4-inch timber frame braces on 4-foot centers. The crest of the saddle dam is at elevation 848 feet MSL.

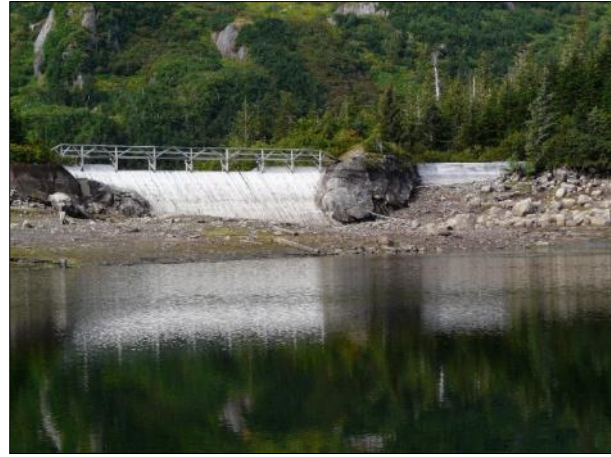
**Figure 3-1. Annex Creek Dam**

Upstream face of dam

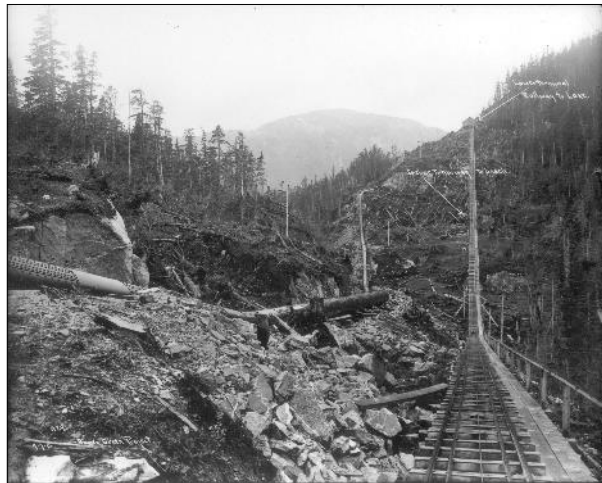
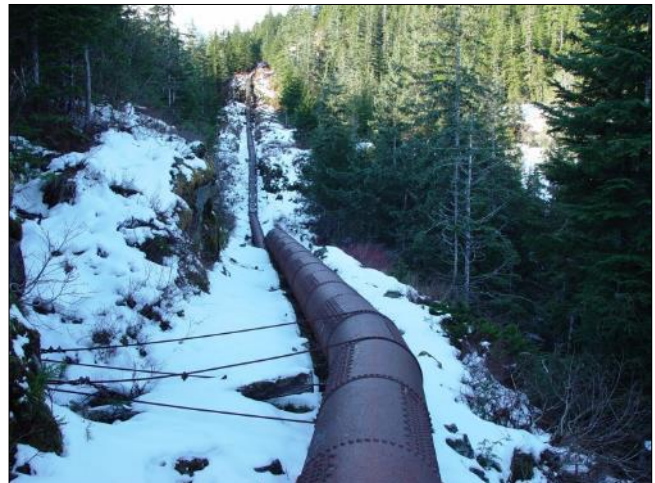
**Figure 3-2. Annex Creek Penstock, during installation and in 2008**

Lake tap: Elevation of invert	690 feet (MSL)
Tunnel structure: Size	8-feet by 8-feet
Total length	1,433 feet
Tunnel linings	Unlined 540 feet (from upstream end) 2-inch gunite lining for the next 628 feet Last 250 feet are reinforced concrete lined
Intake conduit: Number of intakes	1
Pipe dimensions	78 inch
Penstock: Length	7,097 feet
Diameter	Varies from 42 inches to 34 inches
Penstock thickness	Varies from 0.25 to 0.675 inch

During installation

November 2008

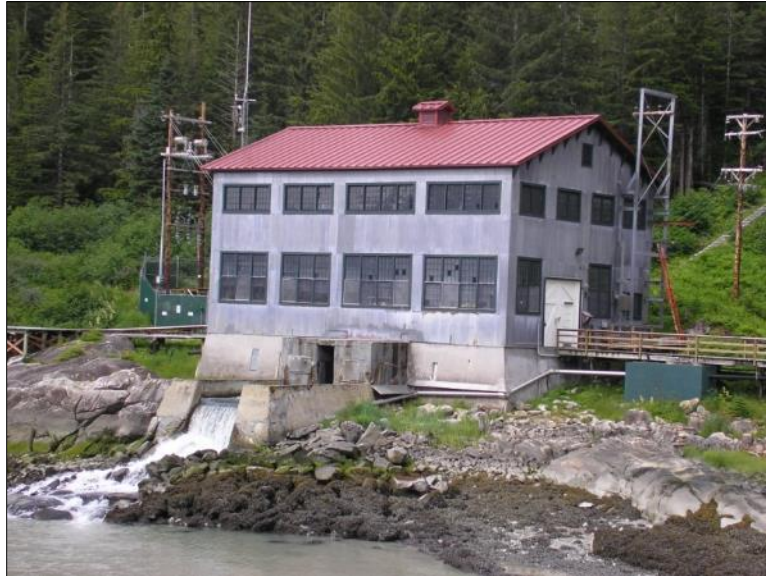
Figure 3-3. Annex Creek Powerhouse

Just upstream of the units, the 34-inch-diameter penstock bifurcates, and an automated turbine shutoff valve is located on each branch, permitting independent operation of the units. A single 34-inch manually operated rising stem gate valve is located just upstream of the bifurcation as a backup. A concrete tailrace, measuring 8 feet deep by 18 feet wide, discharges over a weir into Taku Inlet. The weir crest is at El. 17.41 feet MSL.

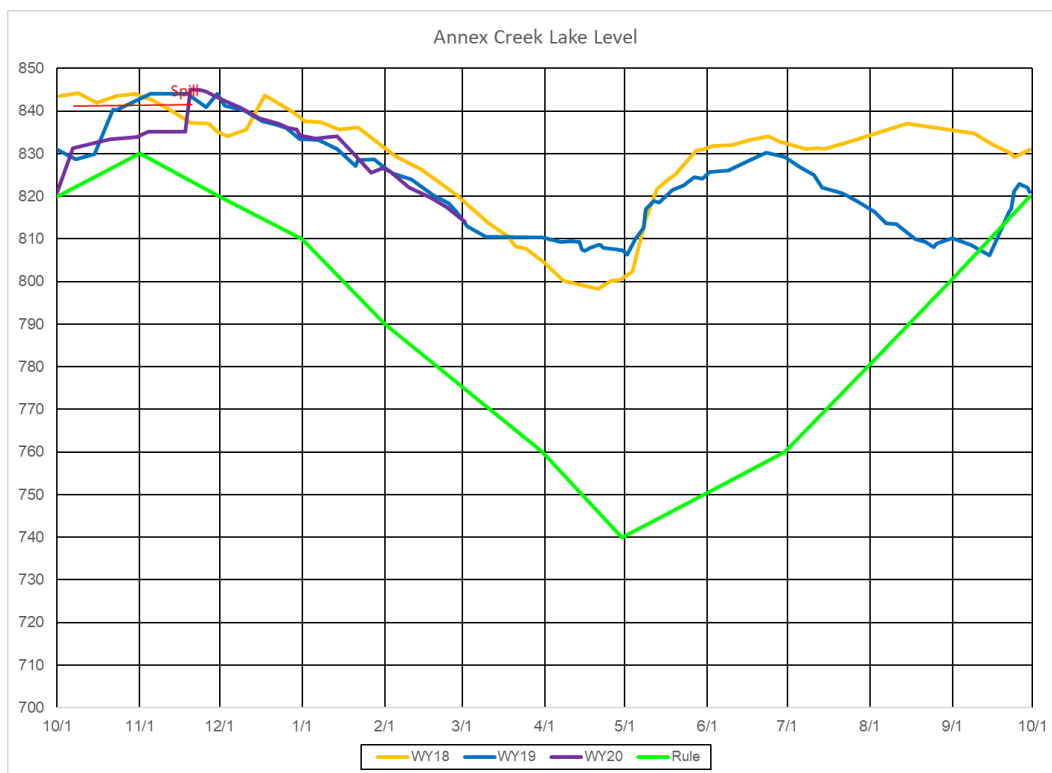
Figure 3-4. Upper Annex Lake water surface elevations, Water Years 2018, 2019 and WYTD 2020

Figure 3-4 shows the water surface elevations of Upper Annex Lake for water years 2018, 2019 and water year to date 2020. The bottom line shows the rule curve, or recommended operation of the reservoir to ensure that it fills back to the maximum operating level each fall for a normal water year. The reservoir typically reaches a minimum elevation around early May and then snowmelt starts to fill the reservoir.

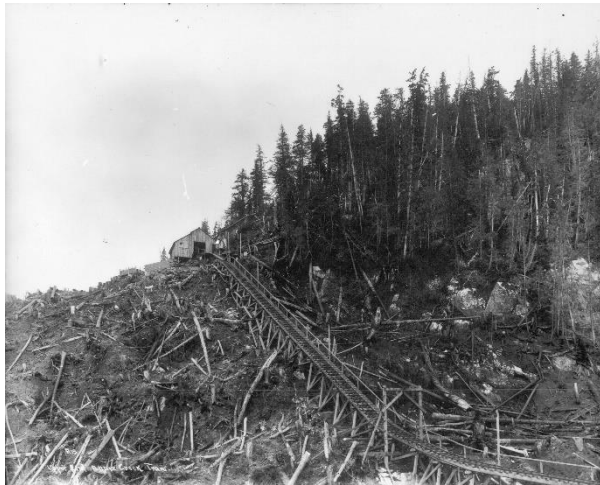
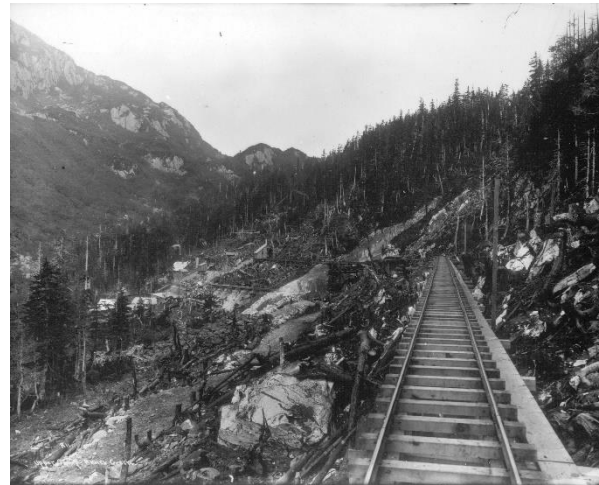
**Figure 3-5. Annex Creek Penstock Historical Disturbance**

There is an existing 40' easement within the P-2307 project boundary which is centered on the existing penstock alignment. It is AEL&P's intention to restrict construction activities to within that boundary unless site conditions found during construction require a small adjustment or additional area to properly secure rock anchors. Figure 3-5 shows the typical ground disturbance of the penstock corridor during original construction, with the railway to the left of the bench prepared for the penstock installation.

Top of Lower Railway

Route Lower Lake

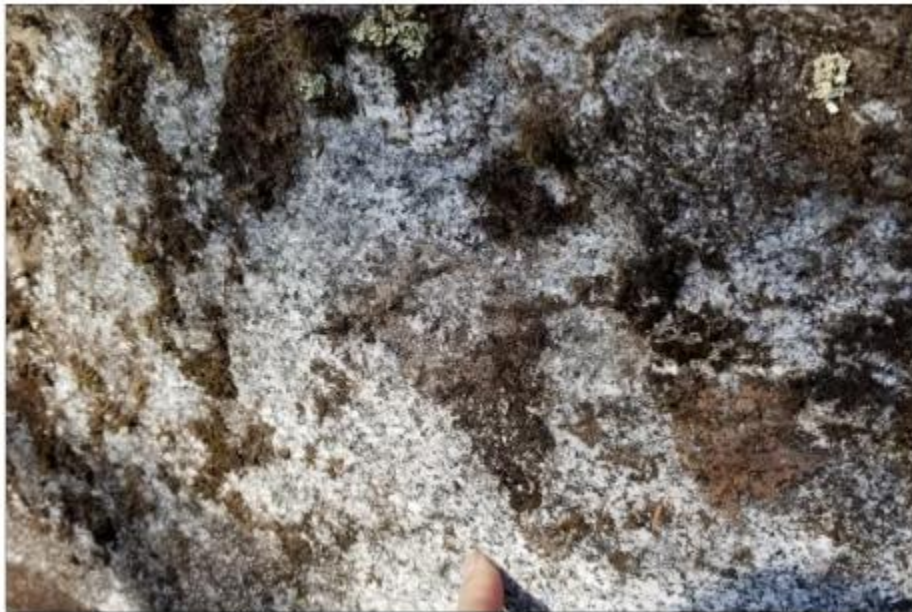
**Figure 5-3. View of Typical Rock Observed along Penstock**

Observed site conditions were consistent with those mapped by Brew and Ford (1977). McMillen Jacobs observed several outcrops along the existing penstock displaying gneissic texture (Figure 5-3). Where exposed, the rock was strong to very strong, predominantly fresh, and generally massive to blocky. Discontinuities were typically moderately to very widely spaced, tight and rough. Typical rock exposures are consistent with very good surface conditions and blocky structure when classified in accordance with Hoek’s Geologic strength index (Hoek et al., 2013).

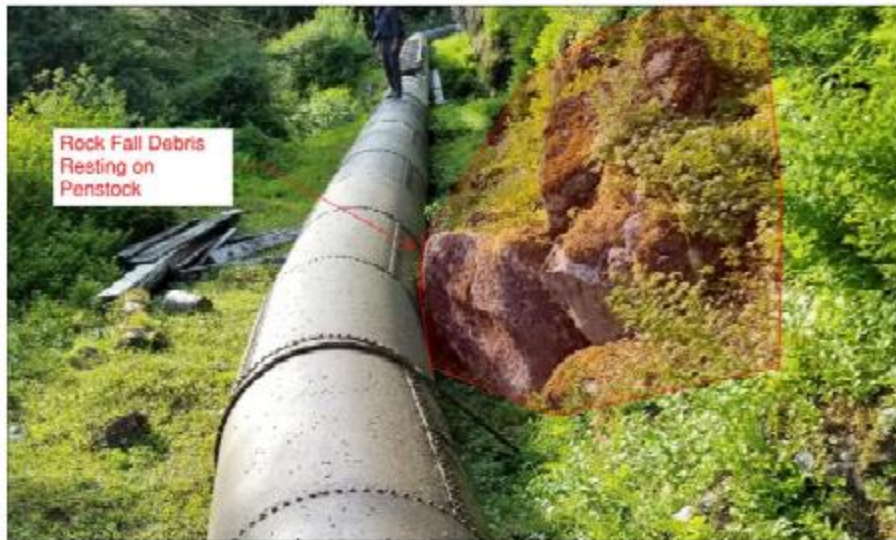
**Figure 5-4. View of Rockfall Debris Observed near STA 26\_75 to 27+50**

Start (Station)	End (Station)	Description	Notes
26+75	27+50	Rockfall from Cut Slope	Figure 5-4
30+50	31+25	Debris from Slope Above Penstock	Figure 5-5, Fallen Trees along Penstock
56+75	57+75	Rockfall from Cut Slope	Large material similar to Figure 5-4
60+75	62+25	Rockfall from Cut Slop	Smaller material similar to Figure 5-4
67+75	69+50	Sloughing from Slope Above Penstock	Figure 5-6

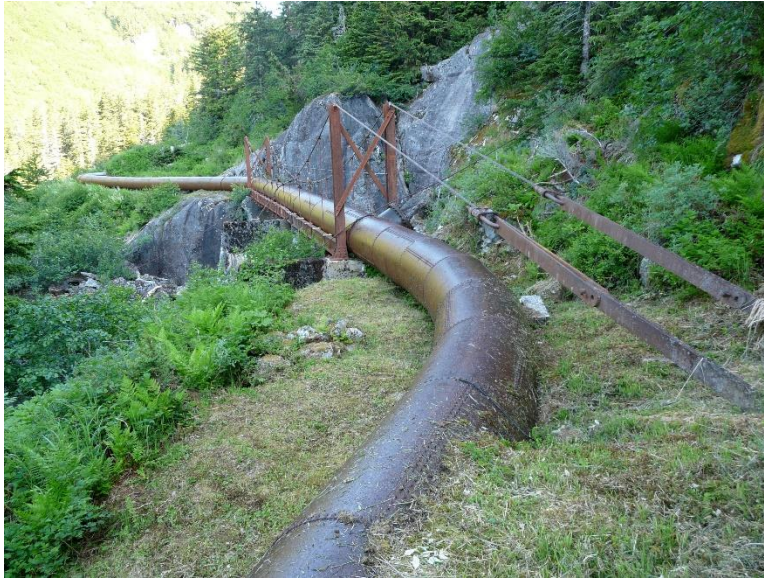
Figure 5-7. Upper Annex Lake Outlet, Penstock Bridge

Like most storage projects in Alaska, Upper Annex Lake is at a minimum level in the spring and then fills due to snow melt and summer precipitation. This construction work will start in the late spring when Upper Annex Lake is at a minimum. With the penstock out of service, it is projected that the lake will fill much faster than during a typical year which will result in water spilling over the dam by mid-summer. Due to the steep gorge at the outlet of the Upper Lake, this should not present any hazards to project personnel during construction. Replacement of the penstock bridge will be scheduled prior to spill and after spill extra safety precautions will be taken when working in this area. Equipment will be staged on either side of the outlet to minimize travel through this zone.

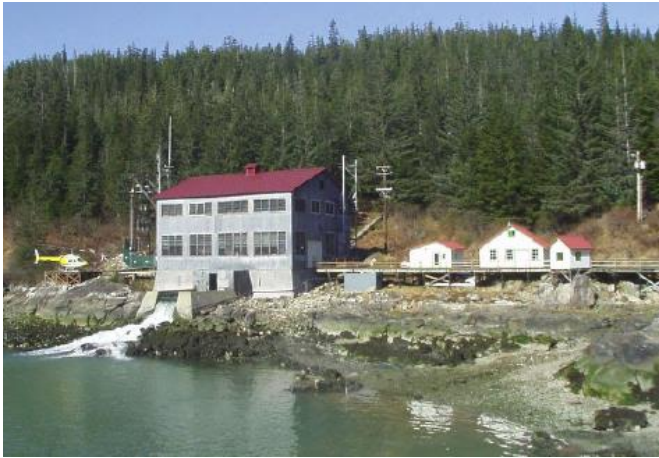
**Figure 5-22. JUN-175, Hydroelectric Plant**

- **JUN-175, Annex Creek Hydroelectric Plant.** This concrete and steel hydroelectric plant (Figure 5-22) is located on the shore of Taku Inlet at the outlet of the penstock pipeline. The building has a concrete foundation, supporting a girder frame consisting of riveted steel I-beams. The building has an open interior and two-tiers of windows on three sides of the building. The building is covered with a corrugated, galvanized steel skin and a gabled metal roof. Inside are two generator units, numerous electrical panels and storage areas, and a bridge crane mounted on I-beams. Water to turn the generators enters through the penstock pipeline and exits from a concrete tailrace. This structure was built in 1915.

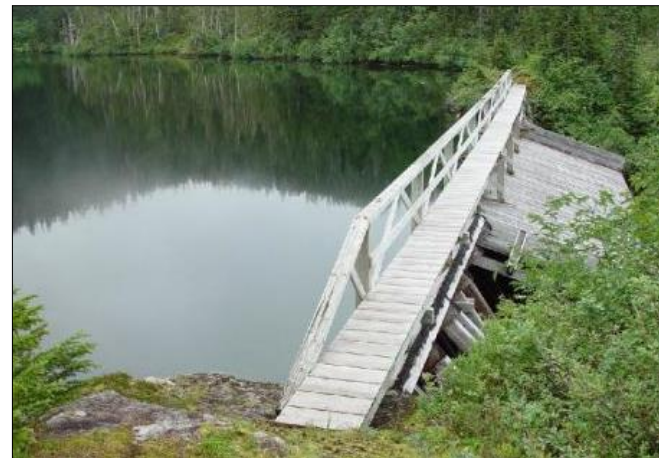
**Figure 5-23. JUN-1098, Annex Creek Dam and Spillway**

- **JUN-1098, Annex Creek Hydroelectric Complex Dam.** This framed timber buttress, plywood-faced dam is situated across the outlet of Upper Annex Lake. The initial structure was a 15-foot-high temporary dam that, prior to the finishing of the tunnel, channeled water over the spillway and through a flume to the hydroelectric generators located at the powerhouse. In July 1935 the dam broke after being hit by a floating log and was not repaired until the spring of 1936 when a new dam approximately 5 feet higher than the original was constructed. In 1966, the dam was found to be in a state of disrepair and was partially replaced the following year (Figure 5-23).

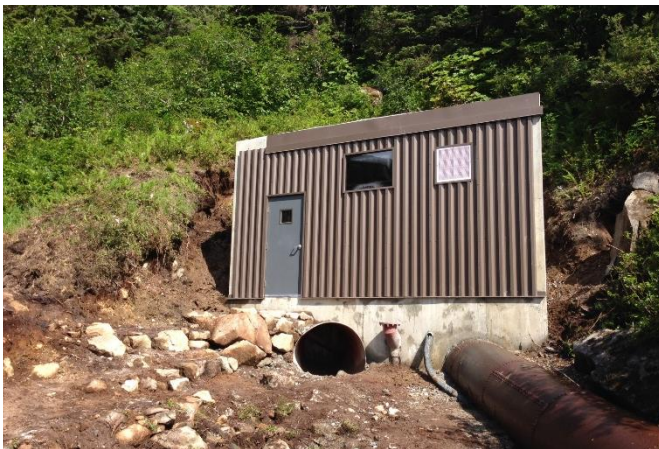
**Figure 5-24. JUN-1100, Valvehouse (modern), located where JUN-1099, Tunnel Ends**

- **JUN-1099, Annex Creek Hydroelectric Complex Tunnel.** The concrete-lined tunnel transports water from the bottom of Upper Annex Lake to the valvehouse located between Upper and Lower Annex lakes (Figure 5-24). Construction of the tunnel began in April 1915 with the lake being tapped on February 14, 1916. This tunnel taps into the bottom of the lake and represents the first time that a lake had been tapped by tunneling into its bottom.

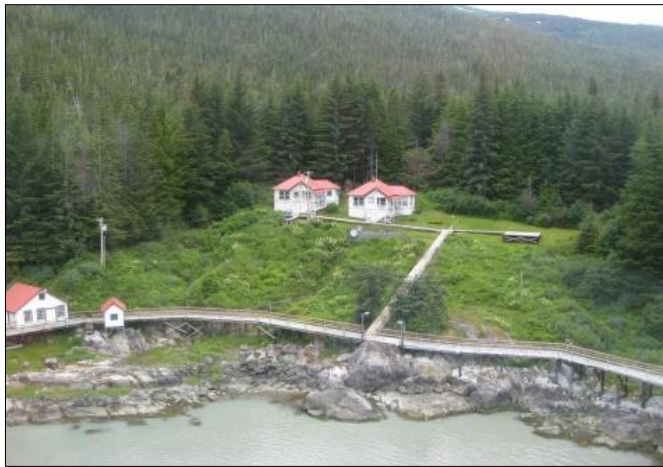
**Figure 5-26. JUN-1103, Blacksmith/Carpentry Shop (far left); JUN-1104, Caretaker's House (rear right); JUN-1105, Employee's House (rear left)**

- **JUN-1103, Annex Creek Hydroelectric Complex Blacksmith/Carpentry Shop.** The single story, blacksmith/carpentry shop (Figure 5-26) is located adjacent to the dock to the northwest of the powerhouse. This is one of the buildings that dates to the original construction of the complex. A 1915 map and historic photographs of the complex show this building at this location. While this building has a sign over the door saying that it is the blacksmith shop, the 1915 map shows a smaller blacksmith shop in another location. This is a wood frame building covered with corrugated galvanized steel sheets. It has a gable roof that is covered with newer metal sheeting. In the interior are numerous electrical insulators and switches that appear to date from the initial construction of the building. It has a wooden plank floor, and interior walls are covered with diagonal, tongue-and-groove wooden siding.

- **JUN-1104, Annex Creek Hydroelectric Complex Caretaker's House.** The caretaker's house (Figure 5-26) is located to the northeast of the powerhouse. This single story, wood frame building was originally built in 1915. It has two bedrooms, a dining room, a living room, a bathroom, and a laundry room. The laundry room and the porch are in a small wing at the east side of the building. It has a skirted wood frame foundation that doubles as a storage area. The exterior walls are covered with horizontal, tongue-and-groove wooden siding. The house has a metal roof that appears to be relatively new. The interior is well maintained and has been extensively modernized. JUN-1105, the employee's house (see below) has an identical floorplan and construction. A 1915 map indicates that originally there were three of these identical houses in a row, whereas now only two remain.

- **JUN-1105, Annex Creek Hydroelectric Complex Employee's House.** The employee's house (Figure 5-26) is located directly west of the caretaker's house. This single story, wood frame building was originally built in 1915. It has two bedrooms, a dining room, a living room, a bathroom, and a laundry room. The laundry room and the porch are in a small wing at the east side of the building. The house has a skirted wood frame foundation that doubles as a storage area. The exterior walls are covered with horizontal, tongue-and-groove wooden siding. The house has a metal roof that appears to be relatively new. The interior is well maintained and has been extensively modernized.

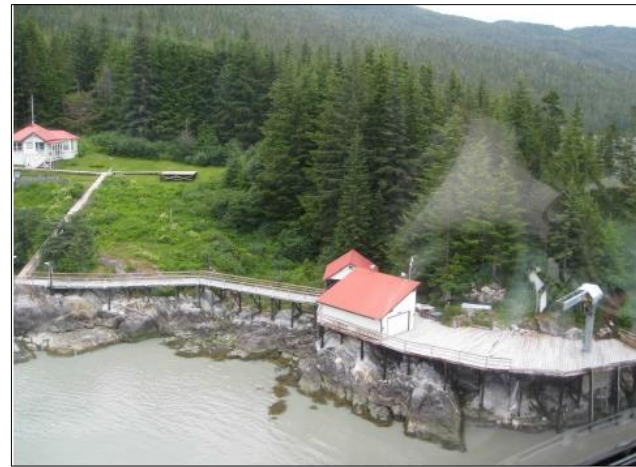
**Figure 5-27. JUN-1106, Dock (lower right)**

- **JUN-1106, Annex Creek Hydroelectric Complex Dock.** The wooden dock is built on pilings that front Taku Inlet on the east end of the powerhouse complex. Maps and historic photographs from 1915 show a dock in this same location, although it had a somewhat different outline and configuration. The deck is covered with modern treated lumber, and it appears that many of the original pilings have been replaced (Figure 5-27). There are two modern plywood and sheet metal buildings on the dock that are used as a boathouse and for storage. There is a modern crane on the far east end of the dock.

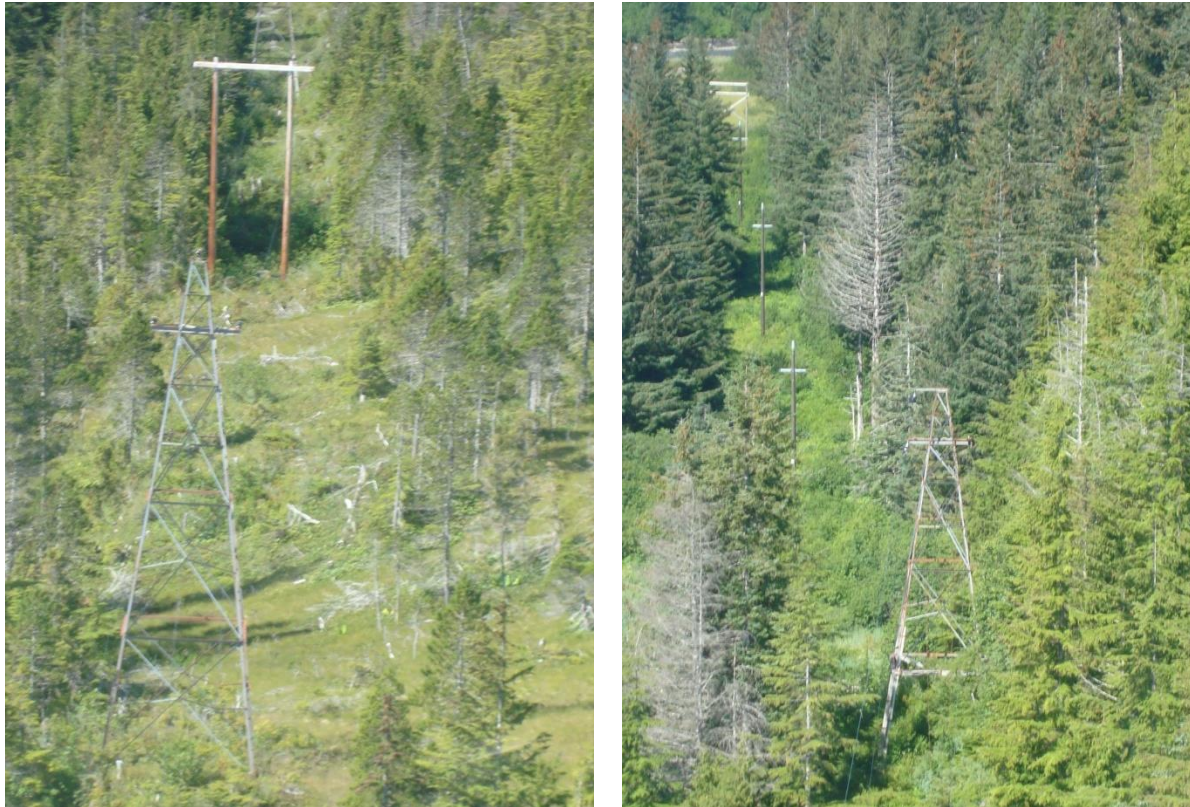
**Figure 5-30. JUN-511, Power Line, showing towers prior to replacement**

- **JUN-511, Annex Creek Hydroelectric Complex Power Line.** The Annex Creek Hydroelectric Complex Power Line (Figure 5-30) is a linear feature that extends from the Annex Creek Powerhouse to Thane. Most of the original towers and other associated features that were built in 1915–1916 have been replaced with wooden structures. The towers were approximately 40-foot tall, and constructed of angle iron. The total number of towers that held up the lines is not known, although maintenance records mention tower numbers in excess of 175.
